NIST NCSTAR 1-5A

**Federal Building and Fire Safety Investigation of
the World Trade Center Disaster**

Visual Evidence, Damage Estimates, And Timeline Analysis

William M. Pitts
Kathryn M. Butler
Valentine Junker

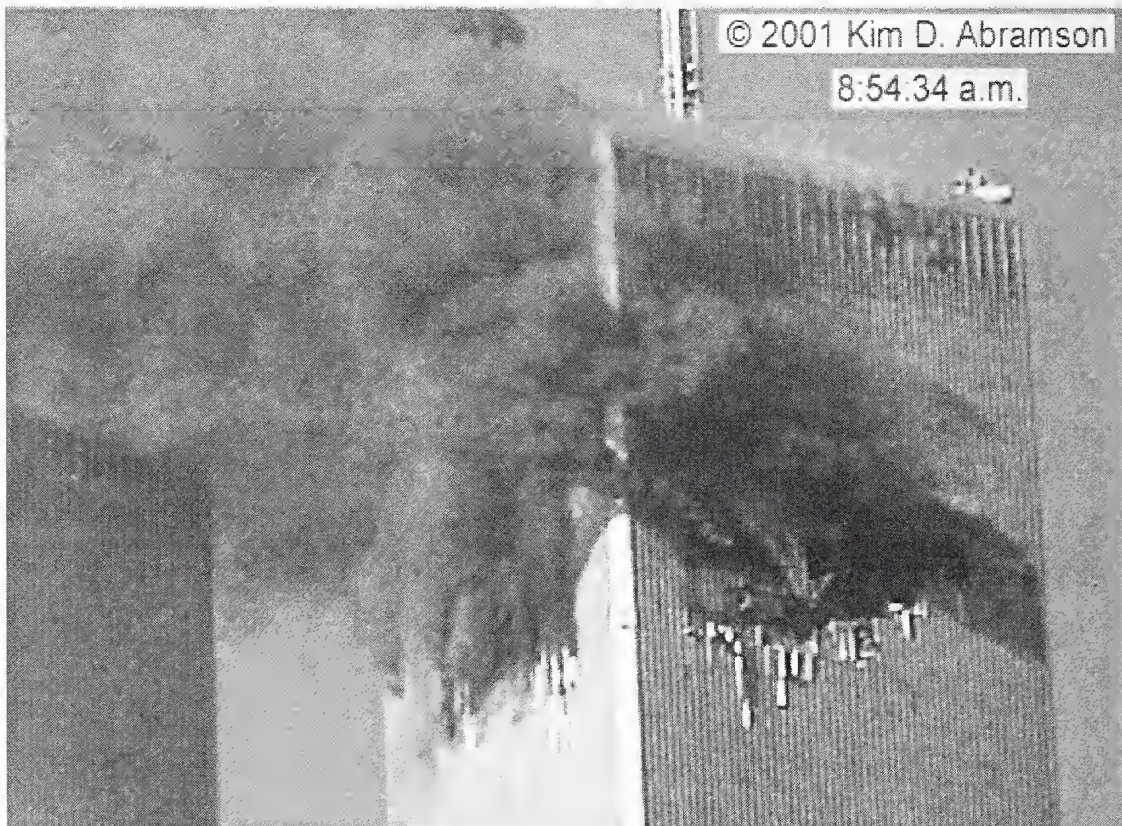
Near the top of the tower in Figure 8-4 there appears to be a heavy flow of smoke from the area of the mechanical equipment room floors near the north edge of the east face. Smoke was present in this region continuously until the tower collapsed over an hour later. This area is close to the exhaust spill louver that served the northeast quadrant of the tower (see Figure A-2), and it is possible that the observed smoke was flowing from this system. However, there is another plausible explanation for these observations based on predictions of smoke movement obtained using the Fire Dynamics Simulator (FDS) (McGrattan 2004). For the simulations, smoke was assumed to come from the 94th floor across

Even though a large amount of smoke hides much of the east face in Figure 8-4, it is still possible to see portions of the façade for floors above the 94th floor where fire is present. This is true for a small region on the lower northern edge and a larger area on the southern side of the face. In these areas smoke was observed coming from windows higher on the face, which indicates that people were also breaking windows on this face at roughly the same time as on the west and north faces. At 8:53:24 a.m. dense smoke plumes appeared at windows 105-245 and 105-246 on the 105th floor. Several additional windows on this floor were broken around this time. The nearly simultaneous decisions by people to break windows on three sides of the tower suggest that smoke had already spread over extensive volumes of the upper floors. Two windows, 99-201 and 99-202, were also broken out on the 99th floor around 8:53 a.m. Light smoke was observed flowing from these windows. Earlier, the windows appeared to be intact.

Figure 8-4. A frame captured from a video shot from the northeast shows the north and east faces of WTC 1 at 8:54:34 a.m. The undamaged WTC 2 is to the left.

In Figure 8-4, heavy smoke can be seen on the east face, coming from a few windows on the 93rd floor, located immediately below the 94th floor where significant fires and smoke flow are evident. An area of light smoke is also coming from a section of the open windows on the 92nd floor. Review of visual material around this time indicates that both the number of windows where smoke was observed and the smoke density appeared to be increasing on these floors. These observations suggest that fires, which were not yet visible from the outside, were growing on these two floors.

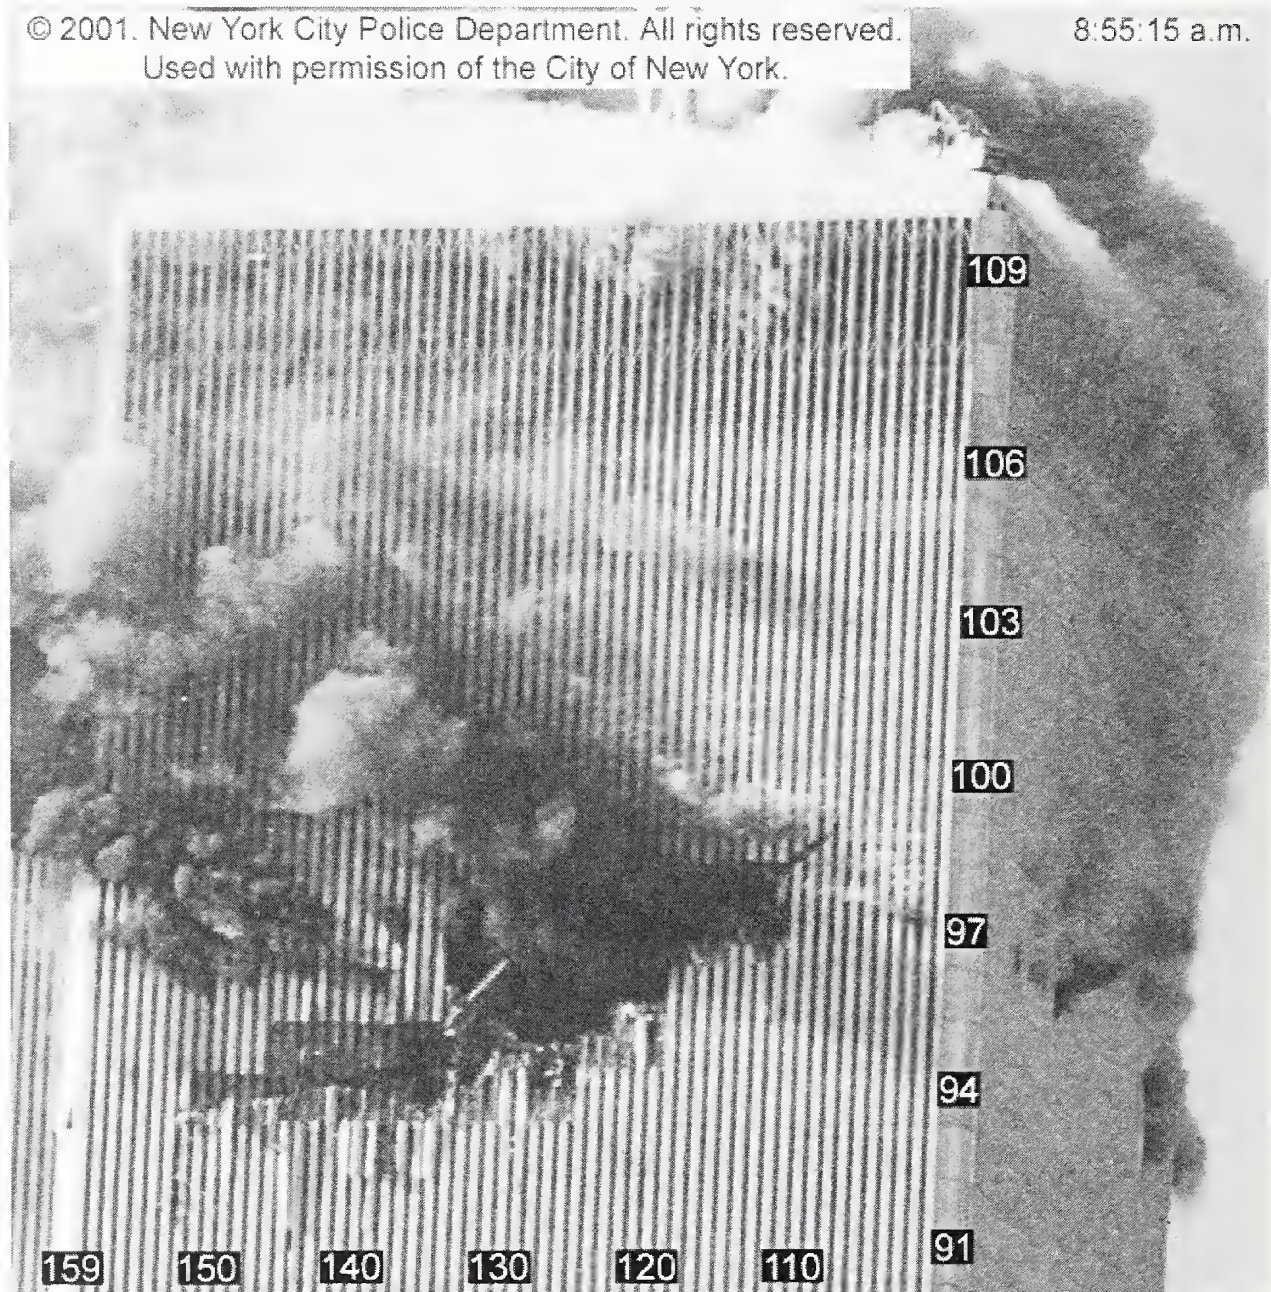
Figure 8-5 was taken just after the beginning of a dramatic change in the fire behavior on the west face of the tower. Videos show that at 8:55:09 a.m. there was a sudden increase in the volume of smoke coming from near window 97-435 on the 97th floor. Almost immediately, smoke began to appear at additional windows, and flames were observed shortly afterwards. The initial stages of this rapid change are indicated by the appearance of smoke at multiple windows on the 97th floor in Figure 8-5. Within a minute following the initial increase in smoke, external flaming was observed from roughly

window 97-430 to window 97-444. The number of windows where heavy smoke was observed was greater, reaching from window 97-425 to window 97-445. In the span of roughly one minute, this fire on the west side of the 97th floor opened windows over a distance of nearly 97 feet.

Figure 8-5. A photograph of WTC 1 recorded at 8:55:15 a.m. shows the north and west faces. The original image has been rotated and cropped. Numbers indicating column numbers for the north face and floors have been added.

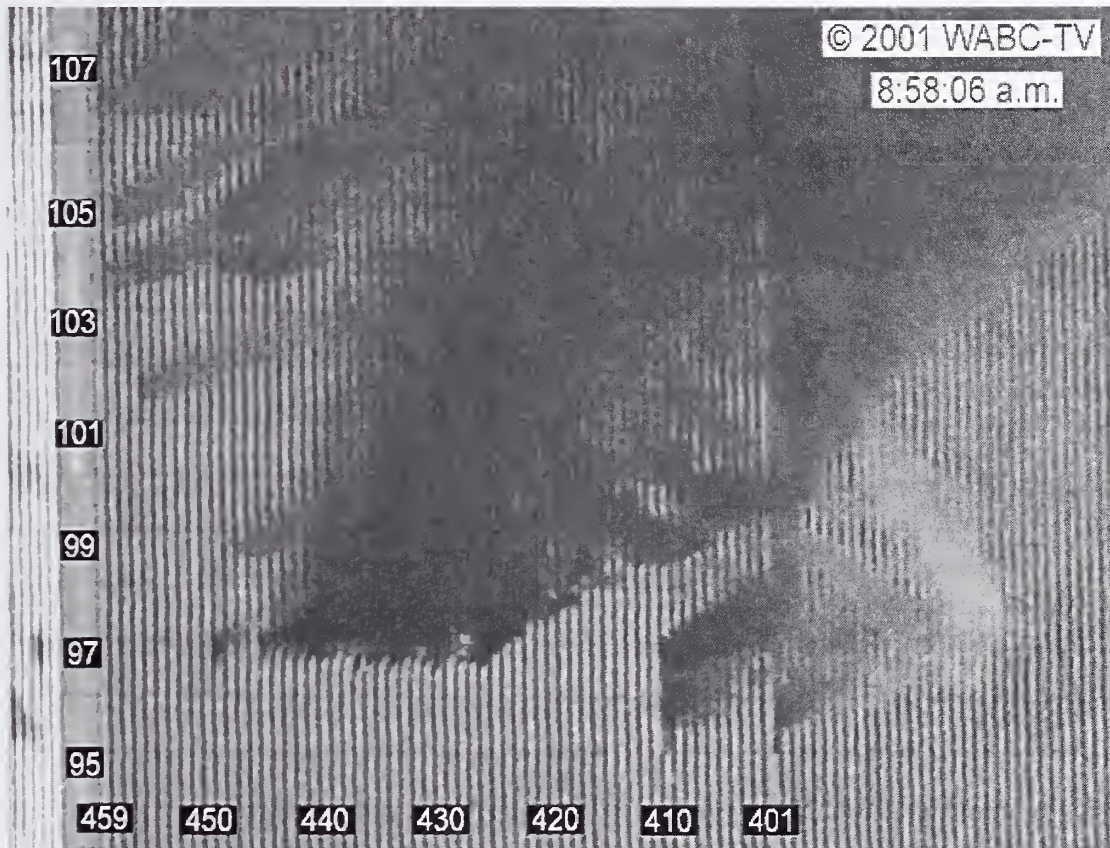
The west face of WTC 1 was filmed from a helicopter around this time. Figure 8–6 shows a frame taken from this video that was recorded at 8:58:06 a.m. Intense fire and heavy smoke are present over the same range of windows observed roughly two minutes earlier. Following the extremely rapid fire spread during the minute that started around 8:55 a.m., the fire appears to have stabilized for a period of time. It

Another feature of the west face around 8:58 a.m. can be seen in Figure 8-6. Numerous plumes of heavy dark smoke are flowing from windows high above the 97th floor on the north side of the face. These plumes are present on the 102nd, 104th, 105th, and 107th floors. People in these areas have broken out the window glass. It is difficult to determine exactly when these windows were opened due to the quality of the imagery during this period, but smoke first appears from the upper regions of the northern side around 8:55:30 a.m. Multiple windows over several floors had been broken by 8:56 a.m., and the number continued to increase during the next two minutes.

Figure 8-6. This image shows the west face of WTC 1 at 8:58:06 a.m. It is a frame taken from a video shot from a helicopter. Floor and column numbers have been added for WTC1. WTC 2 is in the background on the right side. Smoke is flowing from the damaged area on the corner of the 96th floor.

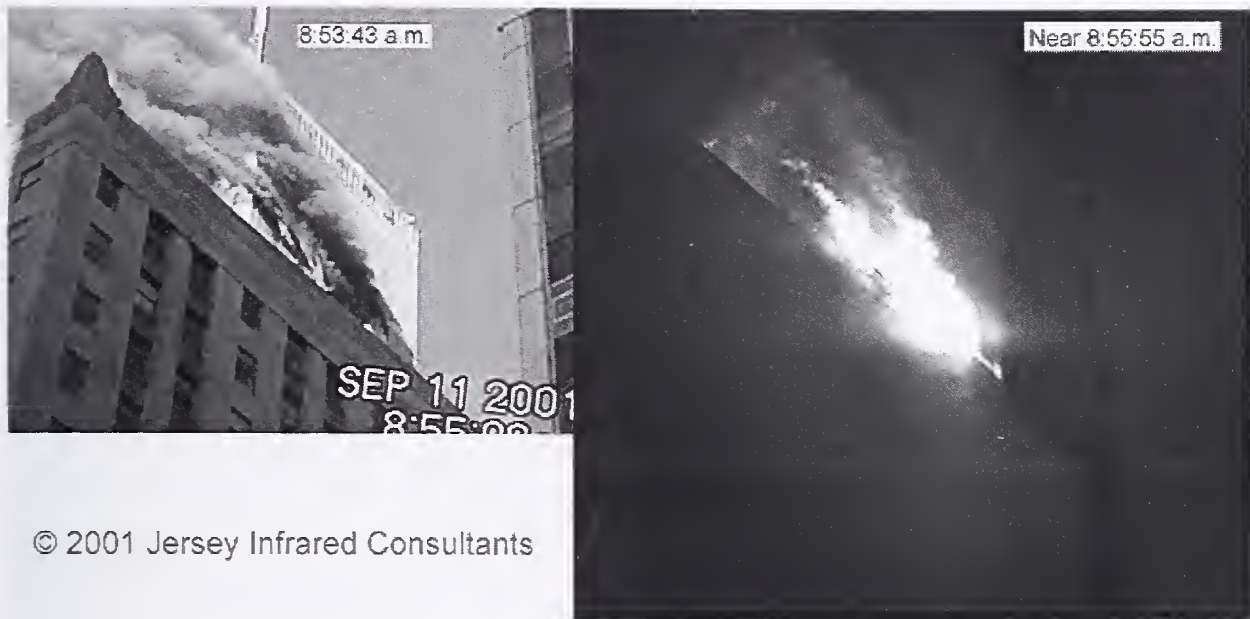
Nonetheless, the infrared images provide unique insights into the heat distribution inside the towers. One of the infrared images showing the north face of WTC 1 around 8:55:55 a.m. (the time uncertainty is estimated to be 15 s) is shown in Figure 8-7. The dimensions of the infrared image are 255 pixels × 240 pixels. It is compared with a frame from a video that was shot from the same location roughly two minutes earlier. The video frame has been rotated and scaled to match the infrared image.

It is immediately clear that large areas of the infrared image are saturated, indicating the presence of strong heating. Even so, there are some interesting features resolved in the image. By comparing the standard and infrared images it is seen that the smoke plumes leaving the aircraft impact cavity and the area of fire on the 97th floor to the east are hot and radiating as they exit the building, but cool rapidly as they move away. There is an isolated bright area near the western edge of the north face, indicating a high temperature region. In Figure 8-5, it can be seen that there is a smoke plume exiting from window 97-102 on the 97th floor. This plume is the source of the high temperature spot. A distinct line connects to the bright spot. This line shows that heat is being radiated from the 97th floor even though, as can be seen in Figure 8-5, the windows are still in place and no smoke and fire are visible in these windows.

The fire on the 97th floor to the immediate right of the aircraft impact cavity has saturated the camera output. Much of the area inside the aircraft impact cavity is also saturated, showing that the smoke flowing from this area was hot. The heat distribution on the east side of the cavity is consistent with the visible fire distribution. There is an extensive length across the face that is saturated. This corresponds to the large fire on the 97th floor that is visible in the video frame and Figure 8-5. This area does not extend all the way to the east edge of the face, and the northern edge of the east face is still relatively unheated. There is a shorter heated length on the floor below that is separated from the aircraft cavity by a cooler

region. This heating is due to the fire that was growing on the 96th floor and had not yet appeared on the face. There is evidence of an isolated fire burning in the eastern half of the 94th floor on the north side.

Figure 8-7. Images of the north face of WTC 1 recorded using a standard video camera (left) and an infrared camera (right) are shown. The frame from the video camera was recorded at 8:53:43 a.m., and the infrared image was shot around 8:55:55 a.m. (the uncertainty is estimated as 15 s) from roughly the same location. The infrared image intensity levels were adjusted. The video frame has been cropped, rotated and sized to match the infrared image. The building in the foreground is the post office on the corner of Church and Vesey Streets.

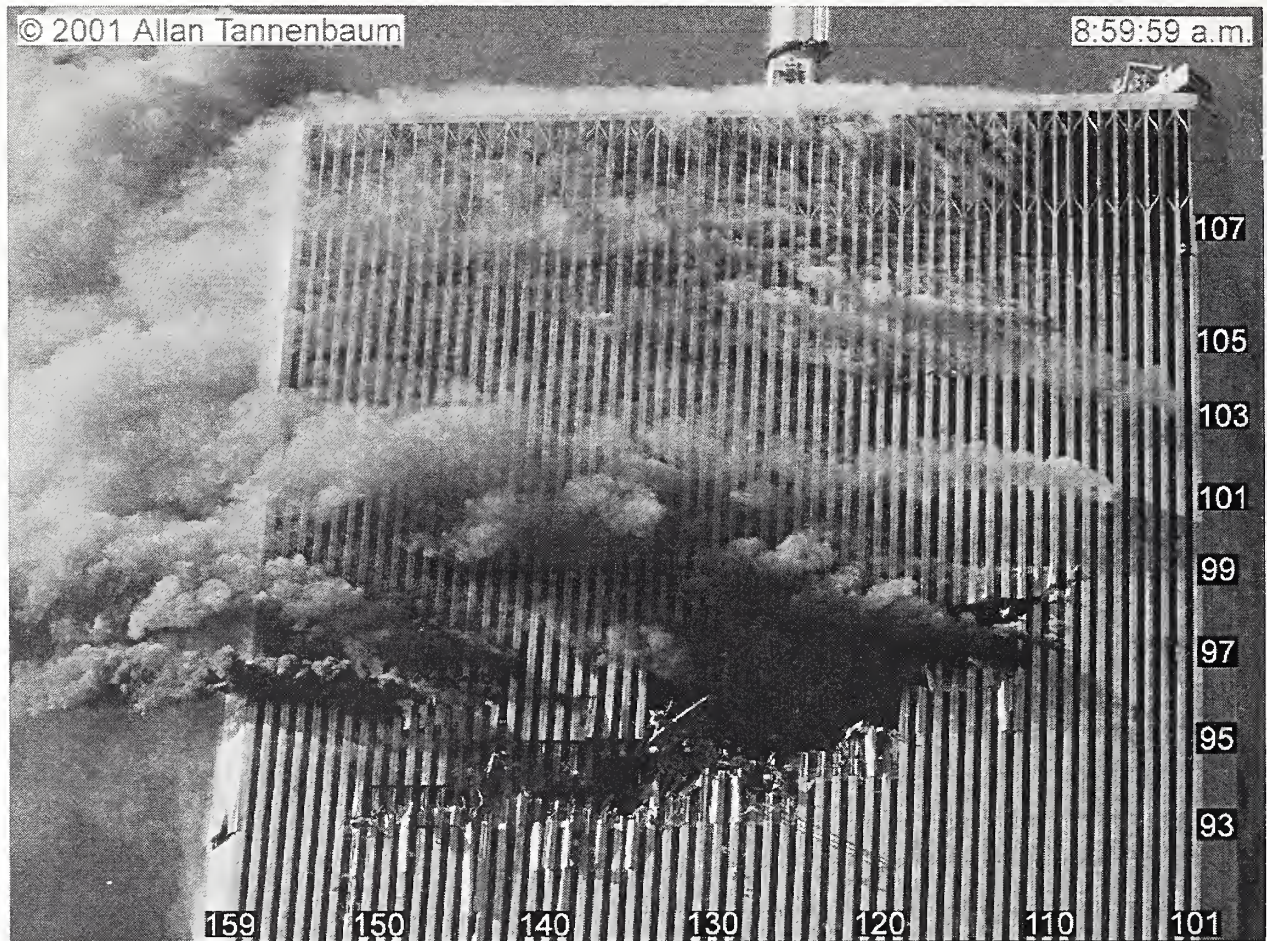
Standard images show that the amount of smoke coming from the windows on the eastern side of the aircraft impact cavity on the 96th floor continued to increase until flames were first observed inside windows 96-145, 96-146 and 96-147 around 8:57 a.m. After this time, fire growth at this location was rapid, and flames extended from window 96-148 at 8:57:18 a.m. Figure 8-8 shows a photograph of the north face that was shot at 8:59:59 a.m. At this time, the fire on the 97th floor to the west of the aircraft impact cavity was still burning, but at a reduced intensity. On the east side of the impact area flames extended from windows 97-151 and 97-152 on the 97th floor, but the fire that was present immediately to the right of this location earlier (compare Figure 8-8 with Figure 8-3 and Figure 8-5) is no longer evident. On the 96th floor, flames are visible in window 96-143 to window 96-149, with external flames coming from window 96-149. At earlier times a small fire was present on the 93rd floor in the vicinity of window 93-143 (see Figure 8-3 and Figure 8-5). This fire is no longer evident in the photograph shown in Figure 8-8, which was taken around 9:00 a.m.

In Figure 8-8, numerous plumes of smoke are seen exiting from windows well above the fire floors on the north façade. There are also many additional windows that have been broken by people at these locations, but they do not have dense smoke flowing from them. The smoke coming from the mechanical equipment room on the 108th and 109th floors can also be seen in this photograph.

Figure 8-8. This photograph of the north face of WTC 1 was recorded at 8:59:59 a.m. The image has been cropped and floor and column numbers have been added.

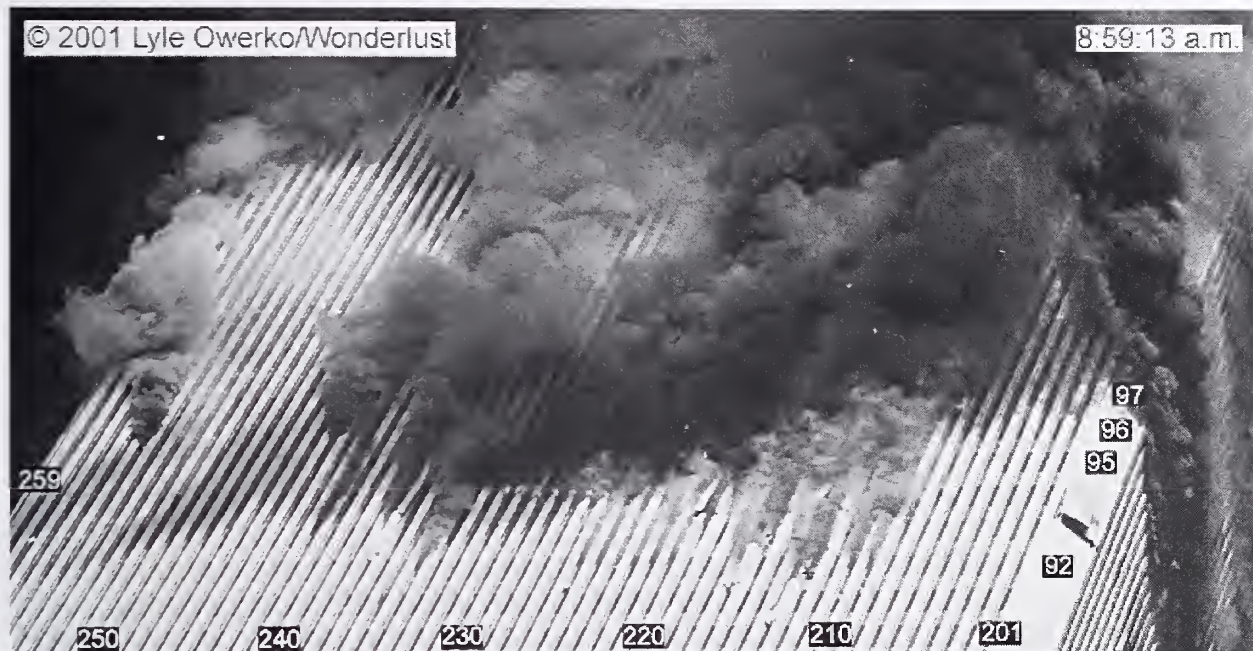
Figure 8-9 shows the east face of WTC 1 at 8:59:13 a.m. As observed earlier, a significant fire continues to burn over a large extent of the 94th floor. Intense burning was particularly evident at windows 94-226 and 94-227. Closer inspection of the photograph shows that distinct “caretts” are present on the column covers next to these windows as well as on the covers for columns 94-229 to 94-232. As discussed in Section 5.2, these caretts indicate that sometime earlier flames were extended out of windows 94-229 to 94-231 and subsequently withdrew back into the windows. These caretts are an additional indicator of the intensity of the fires burning on this floor.

A major change in the east façade fire behavior is also apparent in Figure 8–9. Flames can now be seen at windows 97-208 to 97-210 on the 97th floor. It is difficult to determine exactly when fire growth started at this location due to obscuration by smoke coming from below. However, at least two videos showed flames erupting from these windows at 8:56:45 a.m., while another video showed an intense flame near window 97-211 at 8:58:19 a.m. A close-up photograph showed fire in window 97-114 at 8:57:38 a.m. It seems likely that fire first broke out on the 97th floor on this face around 8:56:45 a.m. and rapidly spread over at least seven windows.

Figure 8-9. This view of the east face of WTC 1 was recorded at 8:59:13 a.m. The original image has been rotated and cropped. Column and floor numbers have been added.

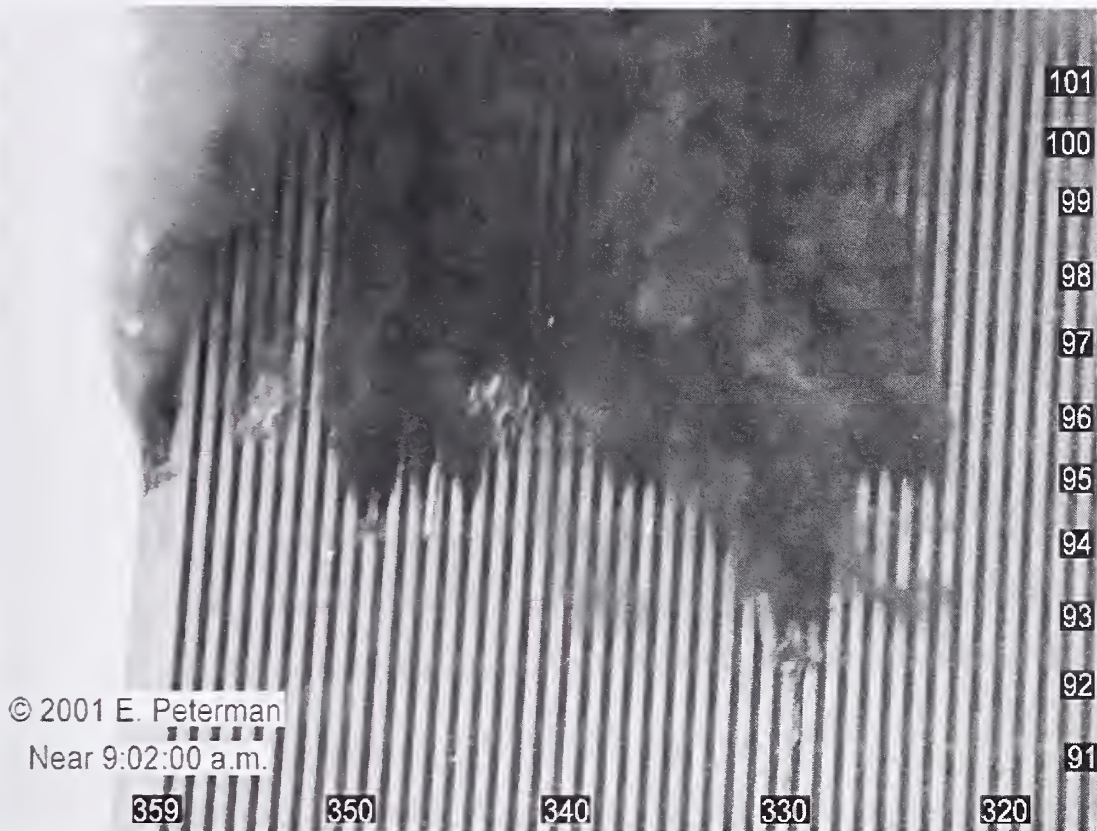
Figure 8-10. This image showing the south face was captured from a video. It was not possible to time this image exactly, but it was recorded within a minute of 9:02 a.m. Column and floor numbers have been added.

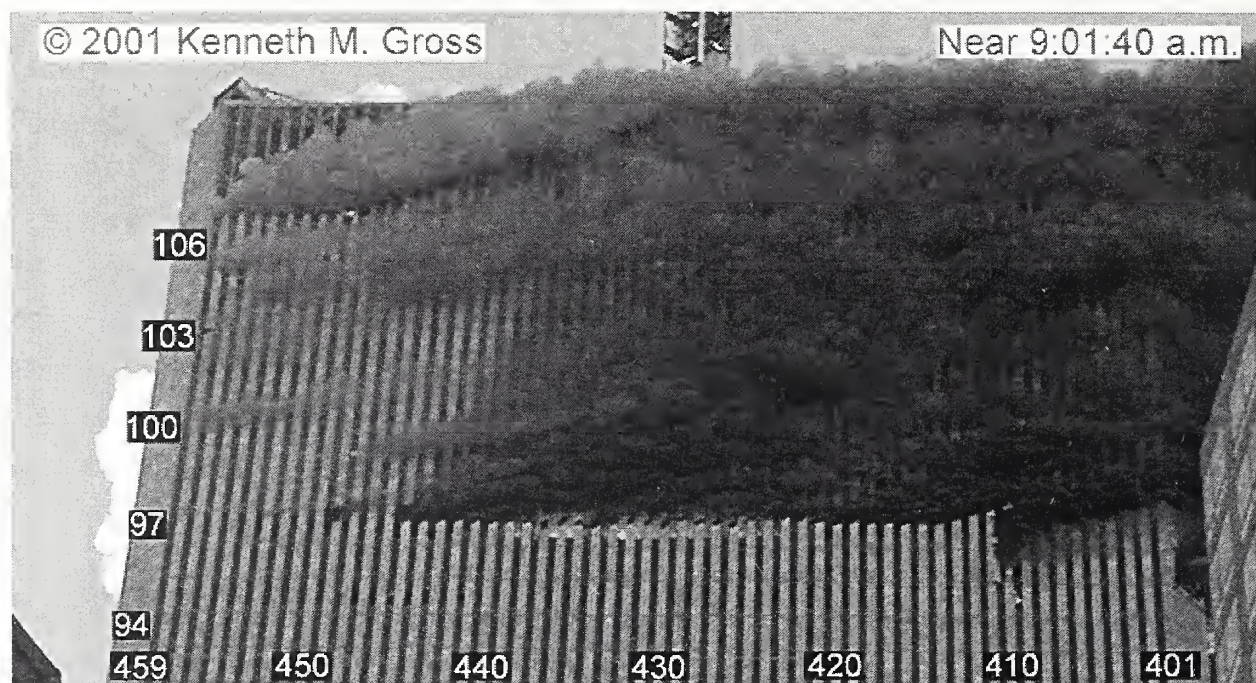
Figure 8–11 is a photograph of the west face of WTC 1 taken shortly after the second rapid fire spread episode. It has not been possible to time this image exactly, but based on observed fire behaviors on this face, it was taken between 9:01:09 a.m. and 9:02:17 a.m., or roughly around 9:01:40 a.m. Intense fires are present in the windows where the initial rapid fire spread took place, and heavy smoke is coming from

windows where the second took place. In the area with flames, carets are present at the tops of the columns, indicating the past presence of flames coming out of these windows.

The figure shows large amounts of smoke continuing to pour from windows well above the 97th floor on the north side of the face. The smoke is particularly heavy from window 107-458. A row of open windows is also present on the 95th floor extending from window 95-441 to window 95-447, with window 95-442 still in place. It is not known exactly when these windows were broken since they were not observed until around 9:00 a.m. They may have been broken during the aircraft impact or by people, who were observed in the open windows. The absence of any smoke or dust coming from the area may indicate that the latter explanation is more likely. The same is true for two windows (windows 92-424 and 92-434) on the 92nd floor that appear to be open in the uncropped version of Figure 8-11.

Figure 8-11. Image of the west face of WTC 1 recorded between 9:01:09 a.m. and 9:02:17 a.m. The image has been cropped and rotated, and column and floor numbers have been added.

Several videos show that heavy smoke was released suddenly from window 97-458 on the north edge of the west face at 9:02:17 a.m. Shortly thereafter fire was observed in this area. Interestingly, there is no indication of a fire at this location in Figure 8-11, which was taken less than a minute earlier.

The open windows on the 95th floor, visible in Figure 8-11, can also be seen in Figure 8-28. There are also four windows, 94-434 to 94-437, on the 94th floor that are now open, but were in place in the earlier photograph taken at 9:01:40 a.m. These windows are believed to have been broken out by people. At this time there is no smoke coming from either set of open windows despite the presence of fires elsewhere on both floors.

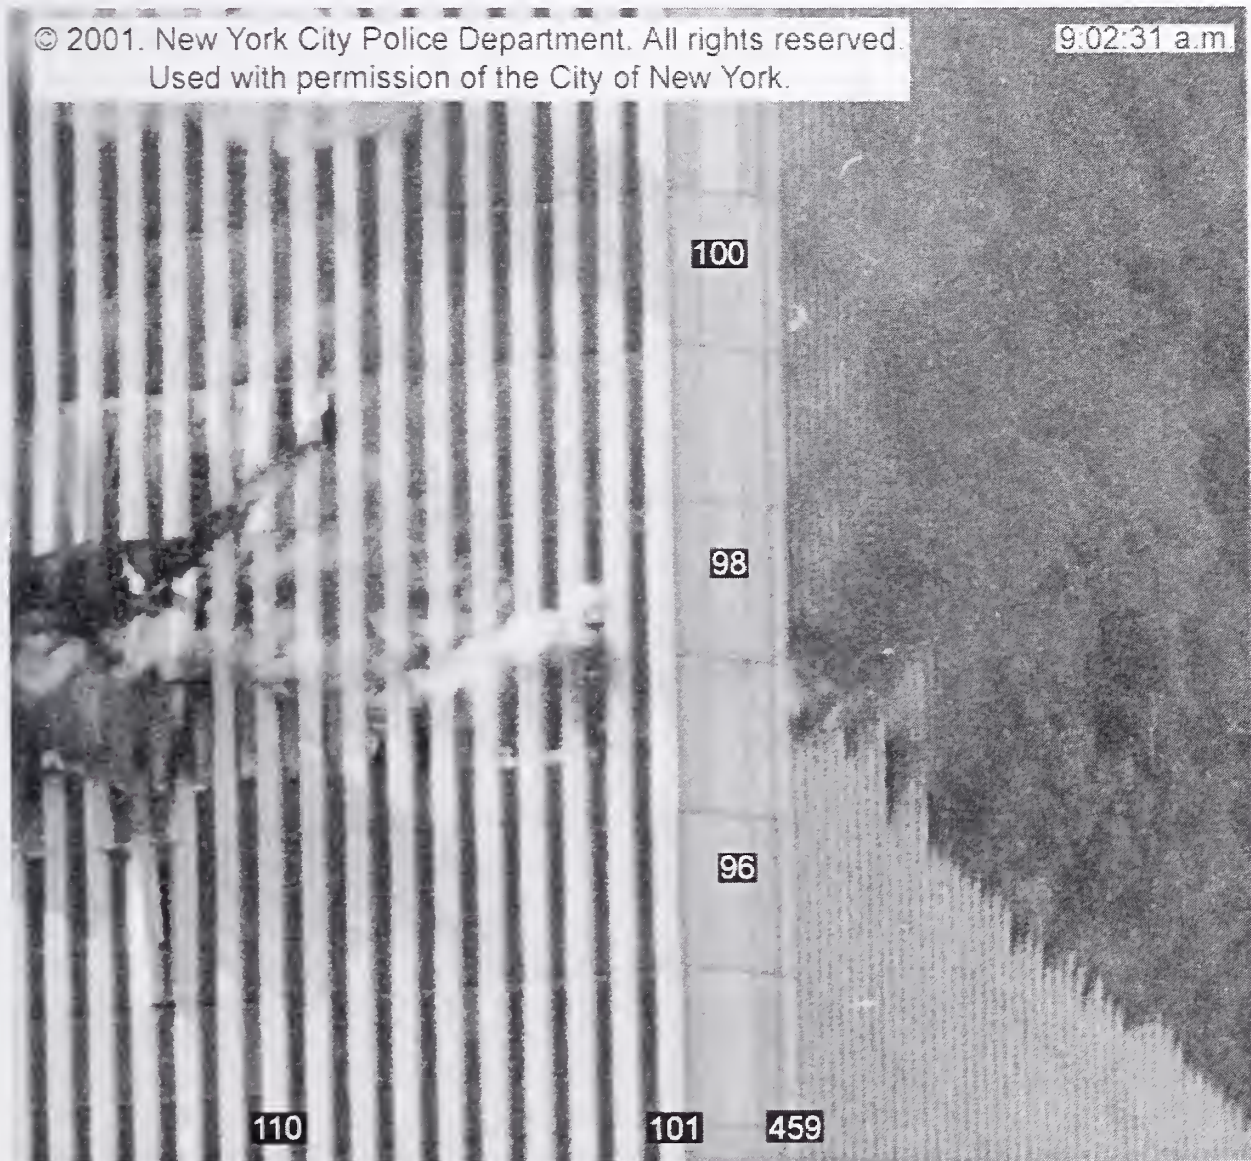
Figure 8-12 shows a photograph of the north face and an oblique view of the west face shot at 9:02:31 a.m., or 14 s after the initial release of smoke at the corner. Flames appear to extend from windows 97-458 to 97-453, and smoke is coming from locations near windows 97-453 and 97-449, as well numerous windows starting near window 97-445 and going toward the south.

In Figure 8-12, fire is present in windows 97-101 to 97-113 on the north face. Window 97-101 still appears to be in place. If so, this observation represents one of the few examples where flames were visible through an intact window. Even though heavy flames are present along the north side of the 97th floor, there is no flame extension, and very little smoke is coming from the windows. It is possible to estimate when flame spread occurred over the final western portion of the north side of the 97th floor. A close-up photograph taken at 8:59:59 a.m. showed that flames were present in windows 97-111 to 97-115, window 97-109 was in place, smoke was coming from window 97-108, and the remaining windows towards the west were intact, except for window 97-102, which had been broken immediately after the aircraft struck the tower. At 9:00:19 a.m. a video shows that heavier smoke started coming from window 97-104 and, shortly thereafter, from window 97-102. Even though the video was shot from a distance, a short burst of flame from window 97-106 was observed at 9:00:20 a.m.

The fire behavior described above suggests that the fire that erupted from window 97-458 at 9:02:17 a.m. was a continuation of the fire spread observed on the north face. It is interesting to consider why the intense fire that grew rapidly over windows 97-110 to 97-116 around 8:50 a.m. did not spread westward for the next ten minutes. A review of the floor plan layouts for the 97th floor (see Figure B-6) shows that

there was a group of three rooms located at the northwest corner of the floor. One of these rooms had a rectangular shape, with one interior wall that abutted column 97-108 and a second that terminated at column 97-456, with the remaining two walls formed by the exterior walls. Based on visual observations, it can be concluded that these walls were able to appreciably slow the fire spread into these rooms. This conclusion requires that these walls remained essentially intact despite the aircraft impact only a short distance away. The sudden appearance of flame and smoke on the west face suggests that flashover occurred in the enclosed space at this time, even though fire seems to have entered the space somewhat earlier.

Figure 8-12. This photograph was shot from the northwest and shows the north and west faces of WTC 1 at 9:02 31 a.m. The image has been cropped and the intensity levels have been adjusted. Column and floor numbers have been added.

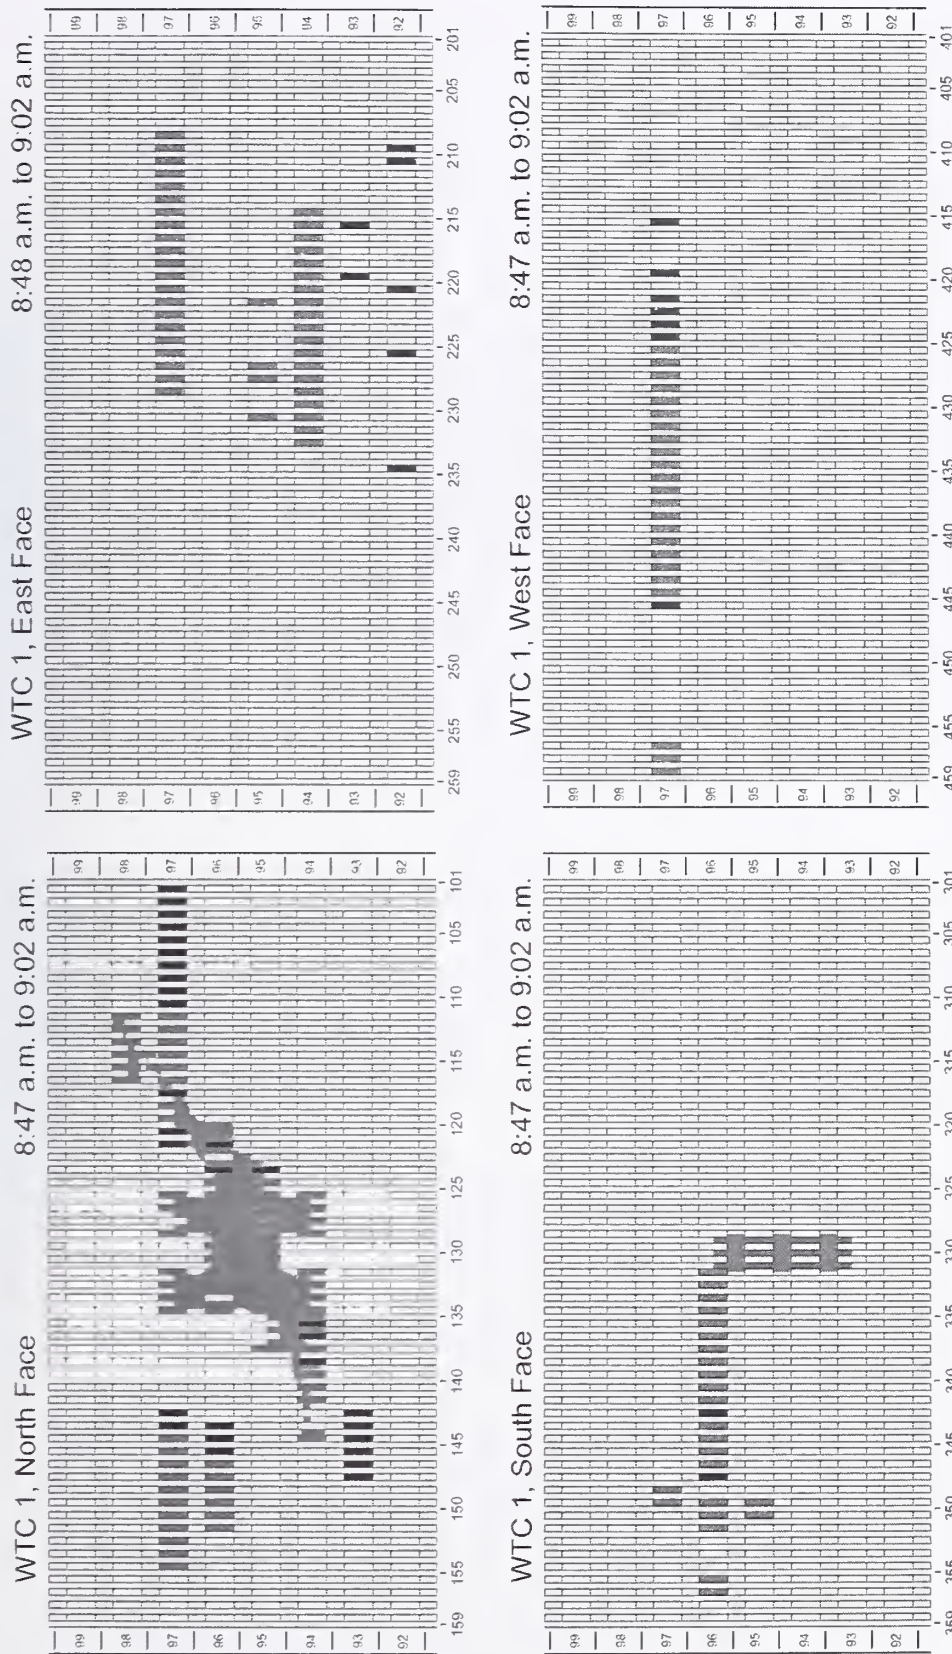
In Figure 8–14, a different type of mapping is used to provide additional insights into the fire behavior during the period. For this mapping, the fire data sheets have been used to generate a description of the integrated fire behavior for each face. The maps are based on new data sheets generated for the four faces in which each window is assigned the highest fire value reported in the fire data sheets for that window during the period. The result shows windows where fire was observed during the period along with an indication for the maximum intensity of a fire in a given window.

Figure 8-14. Maps of integrated fire observations between 8:47 a.m. and 9:03 a.m. are shown for the four faces of WTC 1. Colors represent the highest intensity fire observed in a window using the color scale defined in Figure 5-1.

The extraordinarily rapid fire spread and intense flames observed on the 97th floor are likely associated with the presence of unburned aviation fuel distributed in these areas. As discussed in Section 6.5, a significant amount of fuel was likely dumped on this floor from the starboard fuel tank of the aircraft. The absence of extensive window breakage immediately after impact in locations away from the impact zone implies the absence of significant overpressures, which suggests, in turn, that a large area of the distributed aviation fuel on the 97th floor did not ignite immediately following aircraft impact. This unburned fuel was presumably distributed over areas extending along the intact north exterior wall and the central sections of the east and west walls, since subsequent rapid fire growth occurred in these areas.

As described in Section 6.5, it is likely that significant aviation fuel was also distributed on the 94th and 96th floors during the aircraft impact. On the 96th floor, the observed rapid fire growth to the east of the aircraft impact cavity on the north face could be the result of this distributed fuel. Subsequent rapid fire spread along the east face (see the following section) is also consistent with the presence of aviation fuel. However, up to the current time, no substantial fire growth has been observed on the west side of this floor. Later fire growth on this side will prove to be much less vigorous than on the 97th floor and will move from south to north. On the other hand, fires were observed on the west side of the south facade of the 96th floor shortly after the aircraft impact, and these fires did spread and become more intense during this early period. Recall also that a fireball was observed on the south face, most likely, indicating that ignition occurred somewhere on the west side of the tower, based on the south face damage pattern. These observations are consistent with the hypothesis that a significant volume of atomized aviation fuel on the west side of the 96th floor was ignited during the aircraft impact and that the subsequent fire and overpressure removed a significant portion of the fuel initially distributed in the area.

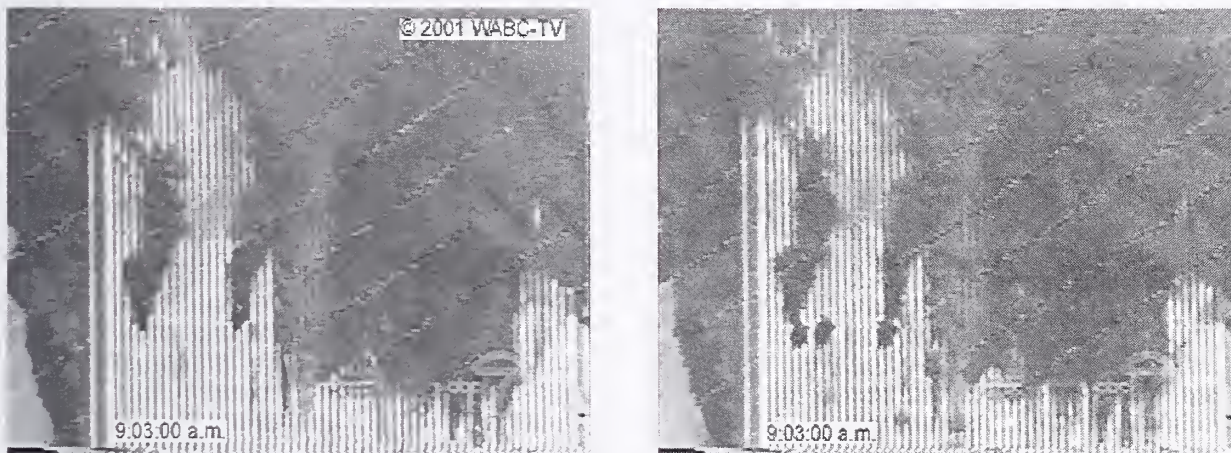
The impact of United Airlines Flight 175 on WTC 2 resulted in some interesting short-term effects in WTC 1. Almost exactly one second after the nose of the aircraft entered WTC 2, a pressure pulse passed through WTC 1 that pushed smoke, and in a few cases fire, from windows located throughout the upper portion of the tower. Figure 8–15 shows the results of this pressure pulse on the east face of WTC 1. The two images are separated by 0.4 s and were recorded roughly one second after the aircraft struck. In the image on the right, puffs of smoke have been pushed out of several windows on the south side of the 96th floor (the floor with smoke coming from a window near the south edge) as well as windows on the 92nd

through 95th floors. Other videos show that almost simultaneously similar puffs of smoke appeared from broken windows on the 92nd, 93rd, 94th, 96th, 97th, 101st, 103rd, 104th, 105th, and 107th floors, as well as from the mechanical equipment room on the 108th and 109th floors. A large burst of flame was ejected by the fire burning on the 97th floor at the north edge of the west face. These observations suggest that a pressure pulse created either by the entry of the aircraft into WTC 2 or the resulting ignition of aviation fuel within the tower was transmitted to WTC 1. The widespread observation of ejected gases suggests that low resistance pathways existed that allowed pressure pulses to be transmitted throughout the upper regions of WTC 1.

Figure 8-15. This figure shows two frames taken from a video that were recorded 12 frames apart, i.e., 0.4 s. The images show the east face of WTC 1 at 9:03:00 a.m.

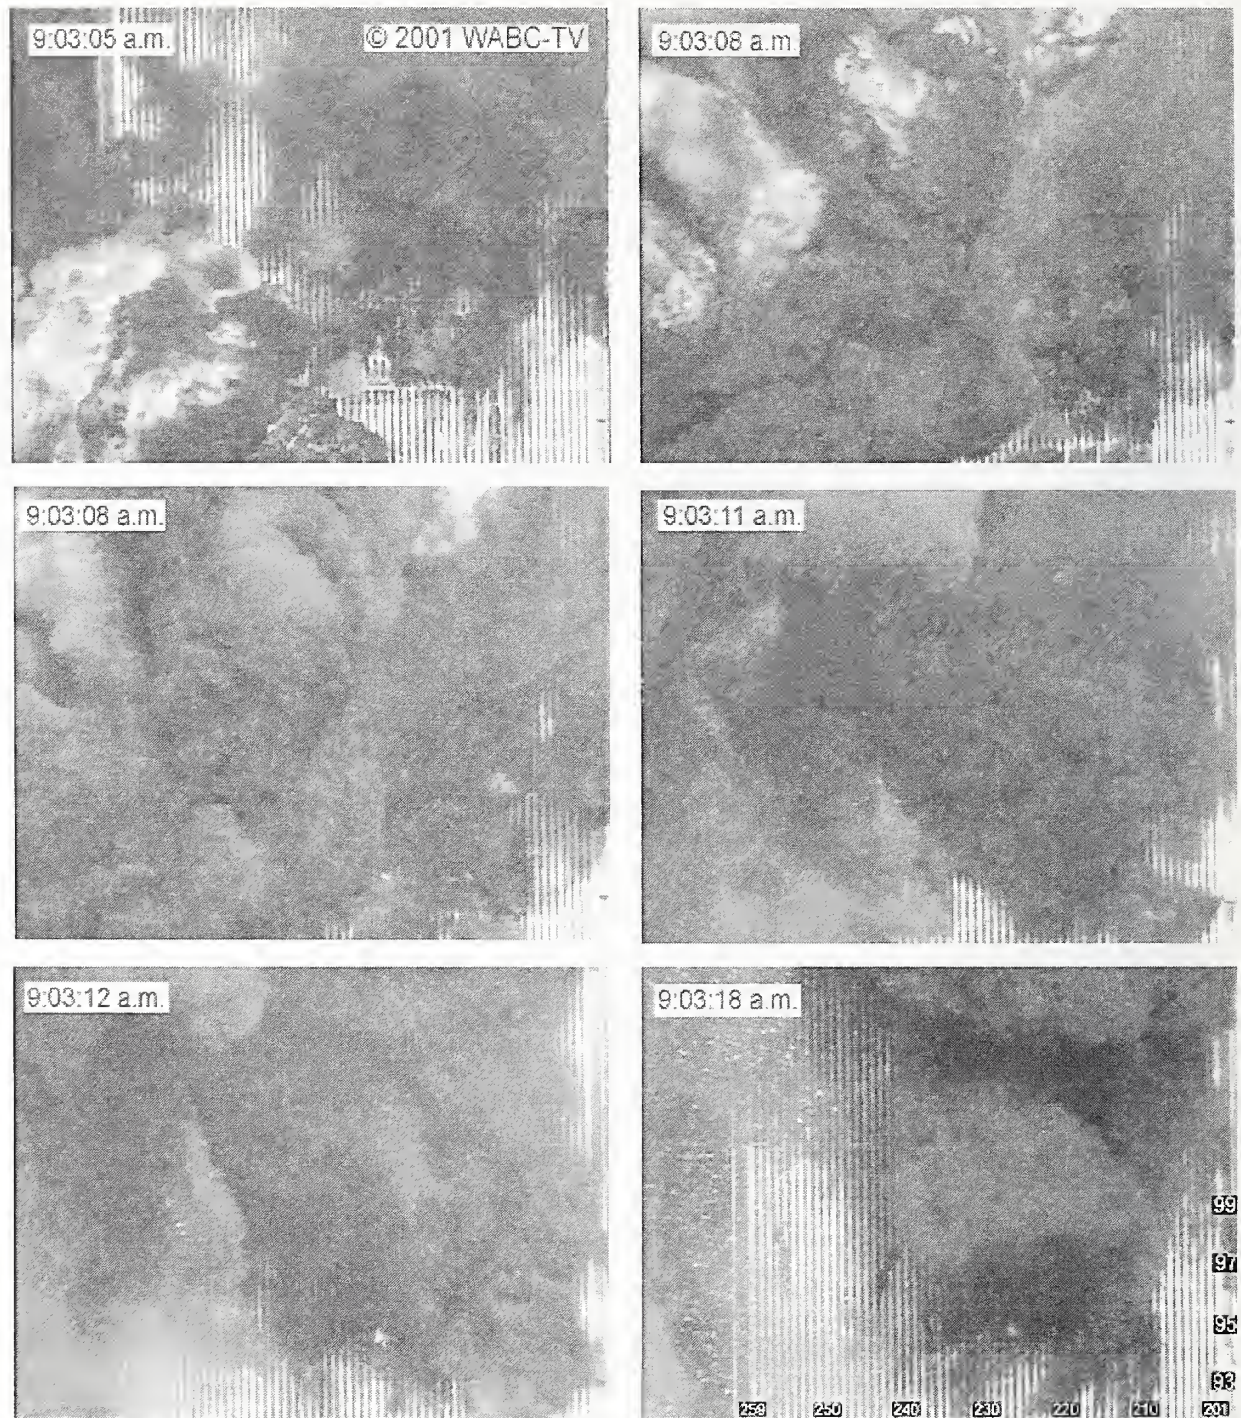
Figure 8-16 shows six frames taken from a video of the east face of WTC 1 during the period when the fireball was forming and rising away from the north face of WTC 2. The fireball itself is visible at the sides of the two earliest images and at the top of the third. In the image at 9:03:05 a.m., much of the smoke has been drawn away from the face of the tower, and it is possible to see the area near the right center of the face where fires have been burning. It is interesting that there are no external flames present at this time. While it still difficult to determine with certainty, it appears as if windows are open on the 94th floor from windows 94-212 to 94-233, on the 95th floor from windows 95-222 to 95-227, on the 96th floor at window 96-224, and on the 97th floor from windows 97-212 to 97-227.

Figure 8-16. Six frames taken from a video of the east face of WTC 1 are shown. These images were recorded during and just after a fireball formed on the north face of WTC 2 following the aircraft impact. Column and floor numbers have been added to the lower right-hand image.

The appearance of the face changed dramatically during the next three seconds. At 9:03:08 a.m. more of the face is hidden by the fireball, but most significantly, flames now appear to have been drawn out of windows 94-216 to 94-218 on the 94th floor, window 95-221 on the 95th floor, and a range of windows on the 97th floor extending from window 97-208 to window 97-227. This is the first image that shows a fire burning on the 95th floor. The next image was recorded 0.6 s later. Flames can now be seen coming from window 93-210 as well as from windows 94-225 and 95-226. At 9:03:11 a.m. the flame extending from around window 93-210 was particularly evident, and at 9:03:12 a.m. the same was true for the flames near windows 95-226 and 95-227. At 9:03:18 a.m. a small flame was observed burning at the top of window 92-212. In this image the flames extending from window 93-209 on the 93rd floor are distinct. Flames are also present on the 94th floor at windows 94-225 and 94-226 and on the 95th floor at two locations around windows 95-220 and 95-226. Even though not easily seen in the captured images, there appeared to be a small fire on the 96th floor near window 96-216 during the sequence.

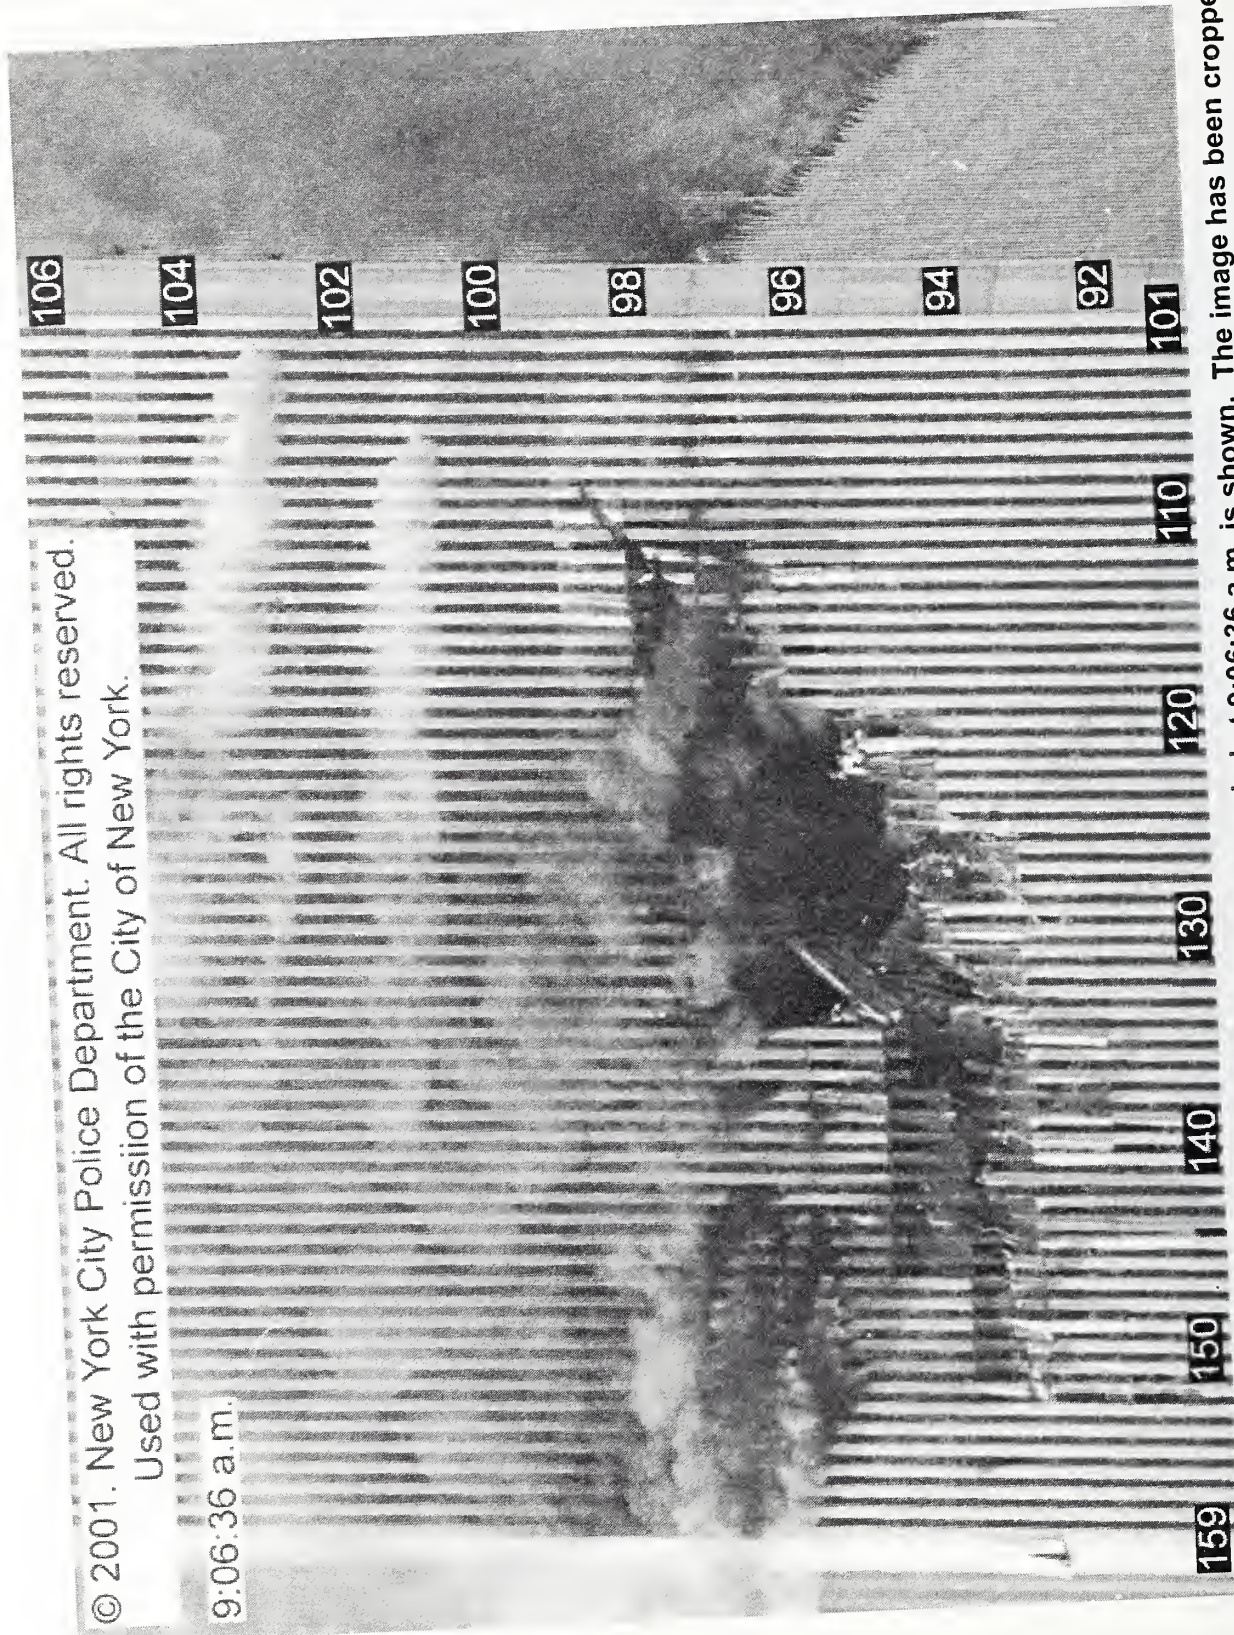
Compared to the rapid fire growth on the north face of WTC 1 during the first fifteen minutes of the event, fire spread during the following fifteen minutes was much reduced. The intense fires that grew on the 96th and 97th floors retreated into the building and began to die down. Figure 8-17 shows a photograph of the north face that was shot at 9:06:36 a.m. Even though the fire on the west side of the 97th floor had spread all the way to the west wall somewhat earlier, the two fires burning eastward on the 96th and 97th floors appear to have stopped spreading. The last window with fire present on the 97th floor is window 97-154. Flames are also evident at the other end of the area, starting at window 97-141. On the 96th floor fire is present at window 96-151, and from window 96-152 on to the east end of the floor, windows appear to be intact. This is clearer in Figure 8-18, which shows a blowup of the area taken from Figure 8-17.

Figure 8-17. A photograph of the north face of WTC 1 recorded at 9:06:36 a.m. is shown. The image has been cropped, rotated, and enhanced. Column and floor numbers have been added.
